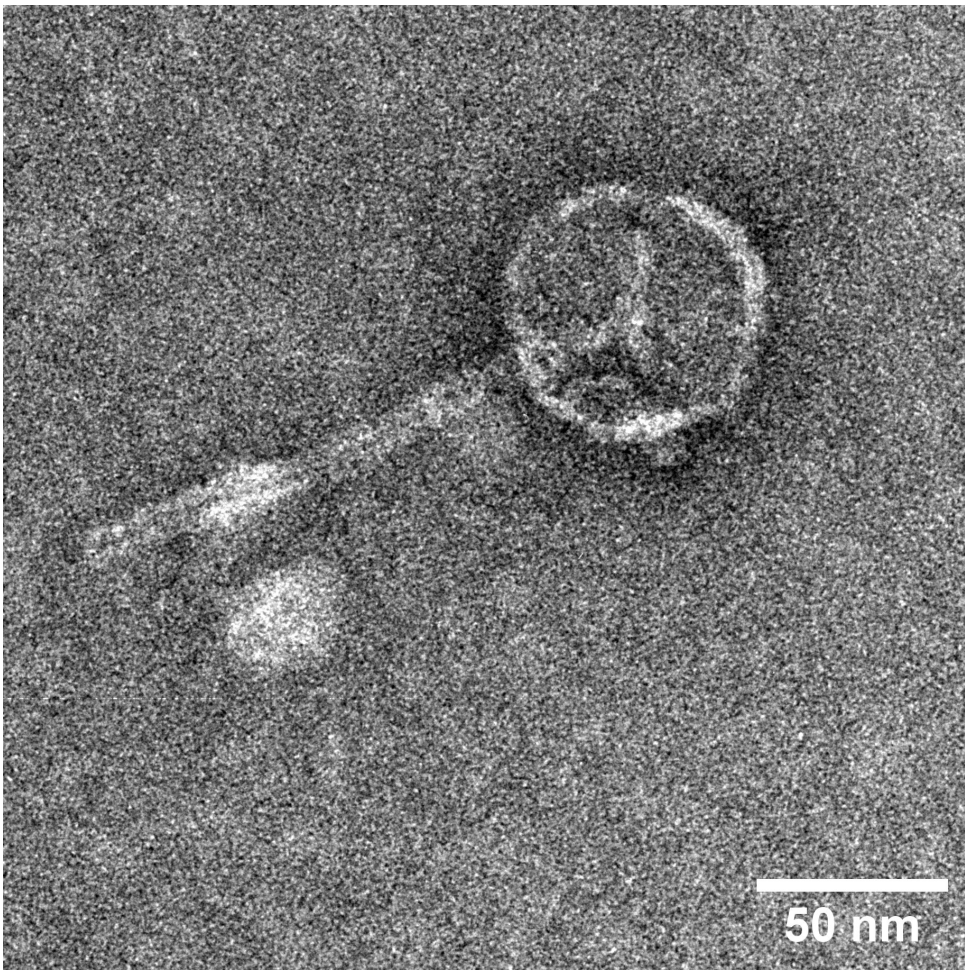
Transmission electron micrograph of Bubicus.
Bubicus was stained with 1% uranyl acetate and imaged at 120 kV.
